MASONIC TEMPLE - THE FORT ATKINSON CLUB CONDITION REPORT

Prepared by:
Charles Quagliana, AIA, NCARB
Preservation Architect
October 1, 2012

Building Envelope Condition Report

May 17, 2012

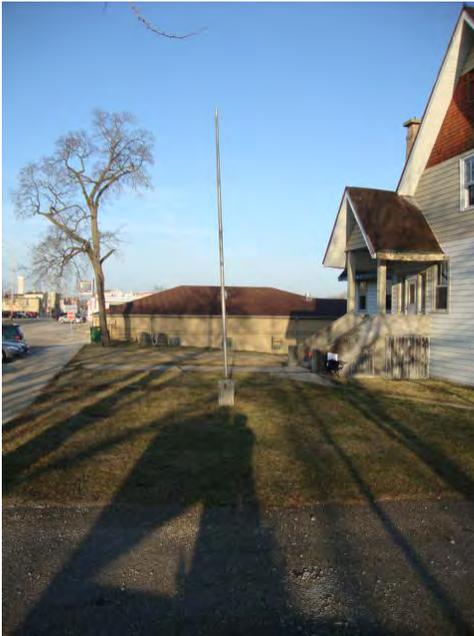
Site drainage is generally very adequate on the east, west and north sides of the building. Rain water and snow melt ponds on the south side of the building along the foundation wall. This is due to the grade sloping towards the building instead of away from the exterior walls.

Image 1.4 View of the south side lawn area facing west. Note the slope of the ground toward the building walls.

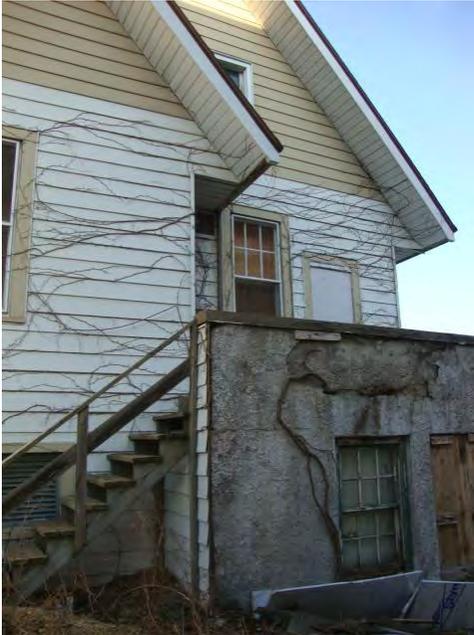
At the north east corner of the building a wind gust tore off the aluminum siding and fiberboard sheathing, exposing the east wall of the basement bowling alley. This has significant delamination of the stucco finish above the windows and some deterioration of the concrete at the lower northeast corner. The wall is in poor condition. The stucco on the entire east side and the lower north side of this corner will require replacement. Significant cracks and deterioration of the concrete foundation wall in these areas will require repair with a high-performance cementitious repair mortar.

Image 1.5 Partial view of the northeast corner wall, east side. Note the delamination of the stucco above the windows and the various cracks.

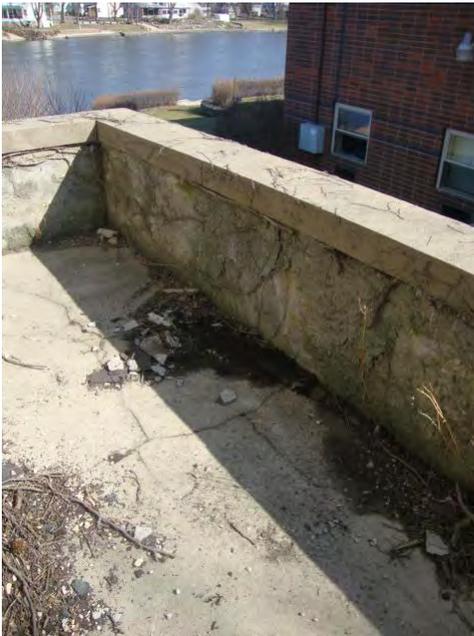
The small porch at the north east corner of the building, at the first floor level, is in generally good condition. The concrete deck surface is worn and has no noticeable slope, drain or protective coating. Rain water and snow melt run down the adjacent wood stairs. Moisture is penetrating the perimeter walls and they are in poor condition with cracking and delamination of the stucco finish. The precast copings at the top of the wall are in good condition but do not appear to have flashing beneath them. The copings need to be repointed. Remedial work for this porch should include: providing flashing below the copings, adding code compliant railings, creating a scupper through the perimeter wall,

Image 1.6 View of the northeast corner porch. Note the delamination of the stucco at the perimeter walls.

providing a protective coating for the concrete deck, removing deteriorated stucco and installing new stucco.

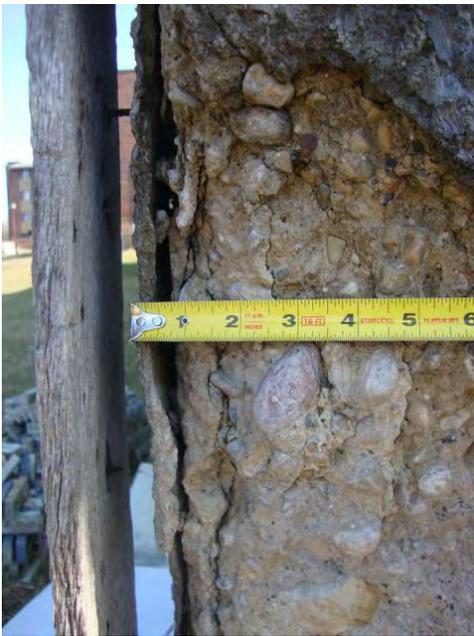
At the northwest corner of the building the stucco is delaminated in large areas on both the west and north faces of the wall. Moisture from the deck (roof) above the basement level bowling alley is penetrating the wall, freezing and expanding, and then spalling the stucco off of the surface. The concrete foundation wall in the northwest corner of this area has become eroded and cracks are appearing due to delamination of the stucco. Repairs are necessary to maintain structural stability. Significant cracks and deterioration of the concrete foundation wall in these areas will require repair with a high-performance cementitious repair mortar. The stucco in these areas will need to be completely replaced.

Image 1.7 View of the corner at the northwest corner of the building. Note the delamination of the stucco and the eroded concrete with aggregate exposed.

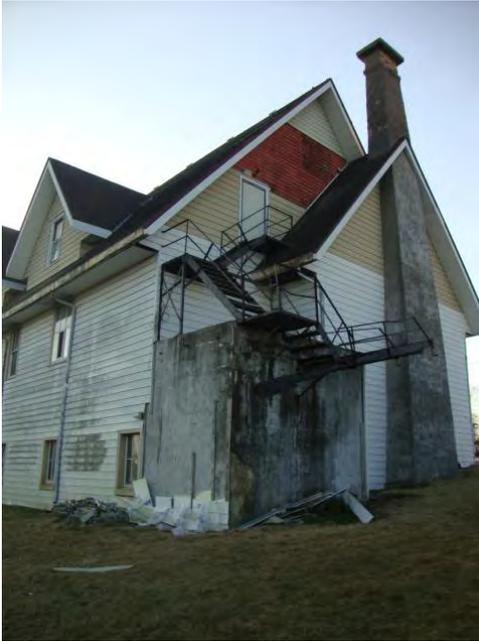
The small porch at the northwest corner of the building serves as a support for the steel fire escape from the second floor. The deck of this porch is covered with a layer of soil and is growing vegetation. The deck does have three scuppers that allow water to drain out the north wall. The stucco finish of the porch walls is deteriorated.

Image 1.8 View of the “porch” at the northwest corner of the building. Note the deterioration of the stucco at the lower area of the corner.

wall, providing a protective coating for the concrete deck, removing deteriorated stucco and installing new stucco.

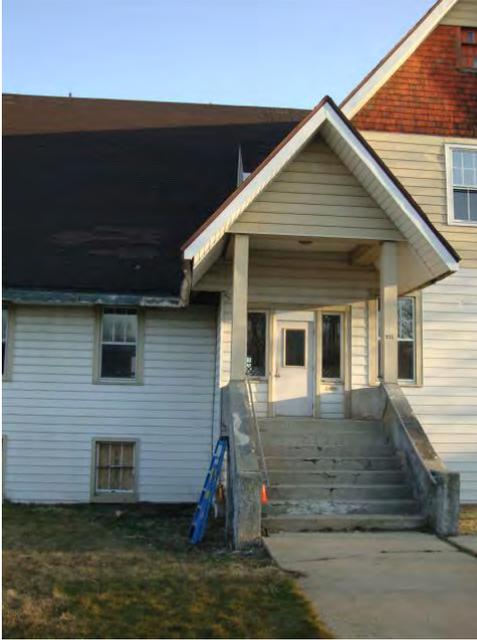
The concrete structure of the entry porch at the south has significant damage due to water penetration and migration. Water and possible snow melting salts have corroded the reinforcing bars causing them to expand, crack and spall off portions of the concrete. The concrete beam below the porch is crumbling and has lost structural integrity. The concrete sections of the porch are deteriorated beyond reasonable repair and should not be used. The concrete structure and roof shingle portions of the porch should be removed and replaced.

Image 1.9 View of the south entry porch. The concrete portions are in deteriorated condition and will need to be replaced.

The wood structure of the porch roof appears to be in good condition and could be reused. The roof is in poor condition and should be replaced. Gutters should be repaired or replaced and downspouts added. The current concrete side walls at the first floor landing and entry stairs are insufficient height to meet current codes and the stair exceed 88 inches in width, requiring a central handrail.

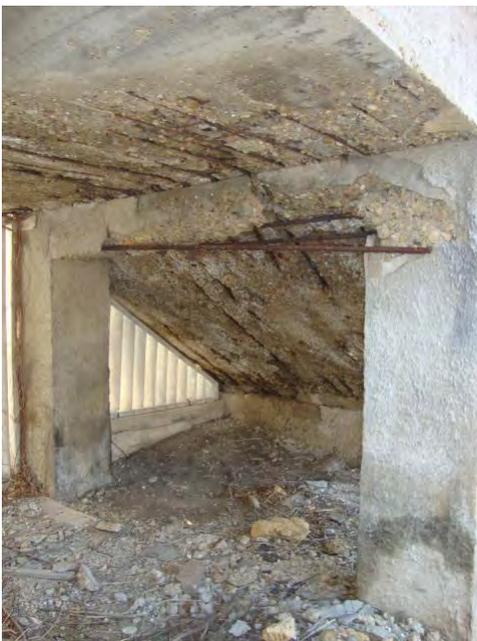
Image 1.10 View of the underside of the south entry porch. Water penetration has rusted the reinforcing bars causing corrosion and deterioration of the concrete.

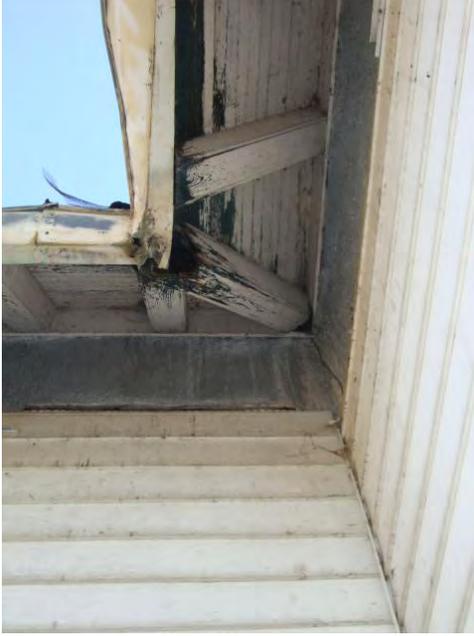
The aluminum cladding has protected the original wood members and their finish. The wood members, outriggers and roof deck, currently under the aluminum siding, were originally exposed to view, typical of this style of architecture. The roof rafters are boxed in with $\frac{3}{4}$ " finished boards to provide the finished outrigger. The finish in the soffit/eave areas is deteriorating but is otherwise providing a function of protection. The condition of the wood is generally good with the exception of the gable intersections where the roof deck and outriggers have suffered water penetration and significant deterioration.

Image 1.12 View of the original soffit/eave area with exposed outriggers and underside of roof deck. Note deterioration at roof edge.

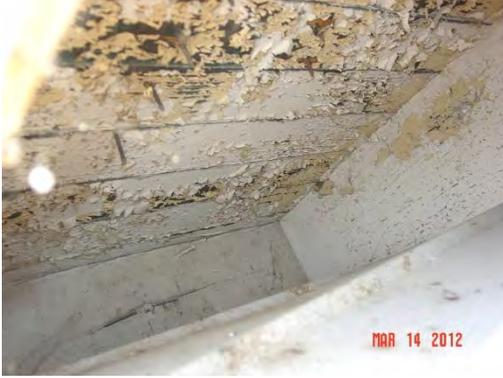
Image 1.14 Typical condition of original members behind the aluminum soffit cladding.

Eventually, the soffit and fascia cladding may be removed to reveal the original wood members. The removal of cladding may coincide with the removal of the siding but performing this action will prove to be difficult if the siding remains in place due to the interlocking at the junctures of the wall and soffit aluminum cladding.

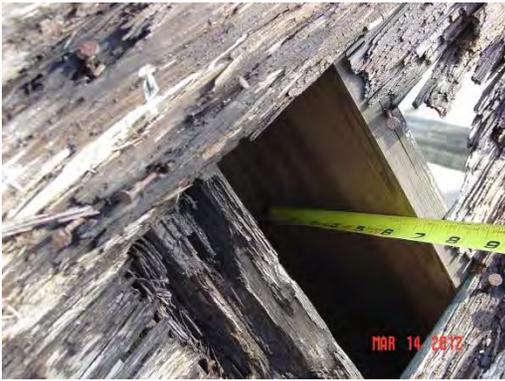
The roofing system and its accessories are in poor condition and beyond their serviceable life. The roof system does require replacement or temporary protection now. Multiple layers of roofing material have disintegrated in localized areas providing zero protection against weather and moisture penetration. It appears the roof structure is sound, and compromised roof system material is minimal and localized. The greatest extent to which roof system reconstruction is subject entails decking and outrigger restoration and is located at gutter edges.

Image 1.15 View of deteriorated roof structure at outrigger at eave location. East elevation.

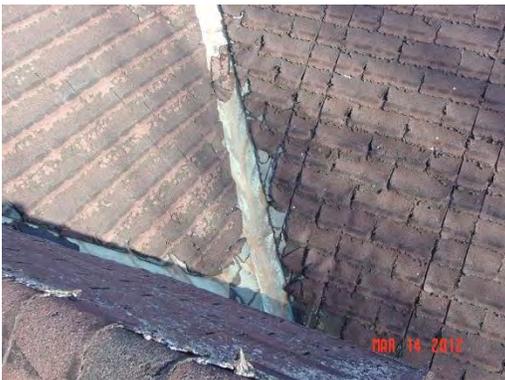
Accessories (flashing) consist of galvanized steel, including counter flashing, valley, and vent flashing. All of the flashing is in poor condition.

Image 1.16 Typical condition of roofing system and accessories (valley flashing).

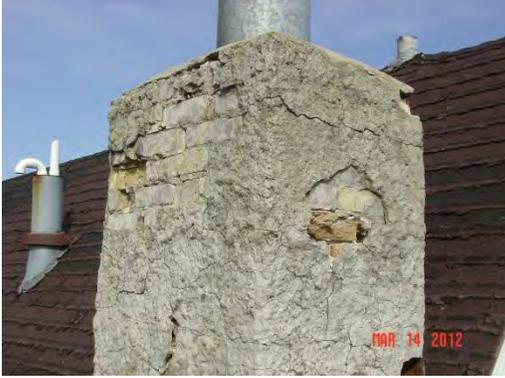
Stucco-covered brick unit masonry comprises the two existing chimneys. Both chimneys are unsound above the roof-line, with the east chimney more significantly deteriorated. The stucco is worn and weathered; approximately 50 percent remains firmly attached. The brick units are also weather-worn, and they are rapidly deteriorating due to moisture entrapment.

Image 1.17 East chimney showing deterioration of stucco-coated brick unit masonry.

Both chimneys require repair and restoration. The brick units must be removed until sound material is discovered, a process called 'down-stacked'. At this time the flue tile should be inspected for its condition. Subsequently, the substrate, including the flue, will be prepared to receive brick and/or tile replacement, utilizing salvage units whenever possible.

The east chimney has been shortened. This chimney requires restoration to its original height and will include brick, mortar, liner and a new concrete cap.

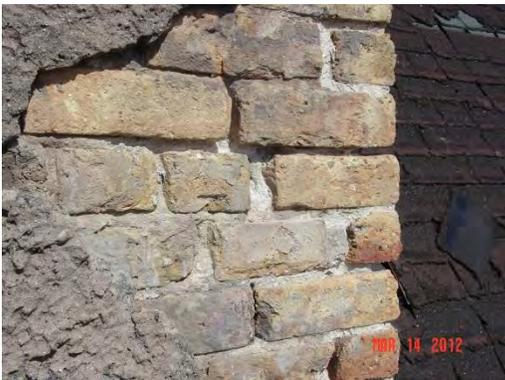
Image 1.18 Typical brick unit masonry condition revealed by deteriorated stucco.

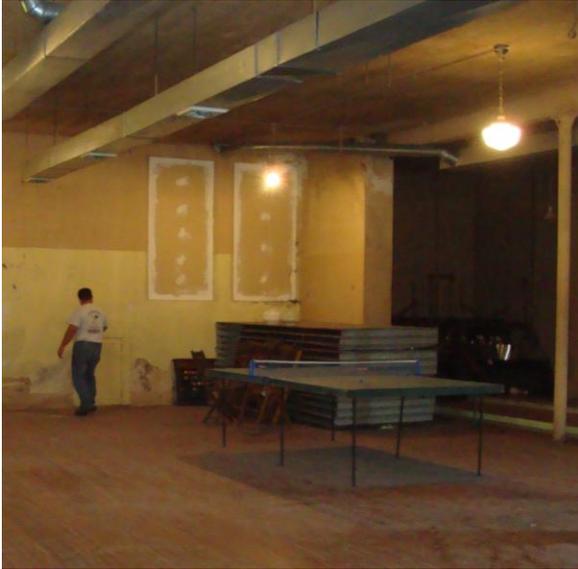
Image 2.2. View of the basement banquet area with the bowling alley to the right. Note the height of the ceilings. The lower portion of the basement level bearing wall adjacent to the men's and women's toilets has deteriorated and compressed resulting in some noticeable deflection of the first floor in the main hall. This wall will need substantial reconstruction which will provide for a level first floor.

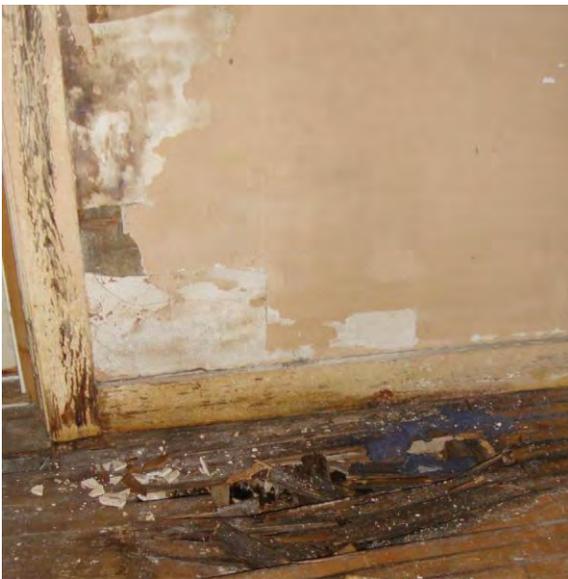
The wood floors are buckled and deteriorated in many areas. About 50% of the wood floors are deteriorated beyond repair and significant work will be required here to replace sleepers and replace wood flooring. Some existing flooring can be reused. Reclaimed or salvaged materials may be used for infill. The finishes and surfaces within the kitchen and toilet rooms are deteriorated and will require complete replacement. Fixtures and cabinets are outdated and water damaged and also must be replaced.

Image 2.3. Deteriorated wood floor and lower plaster wall adjacent to the exterior door, basement level.

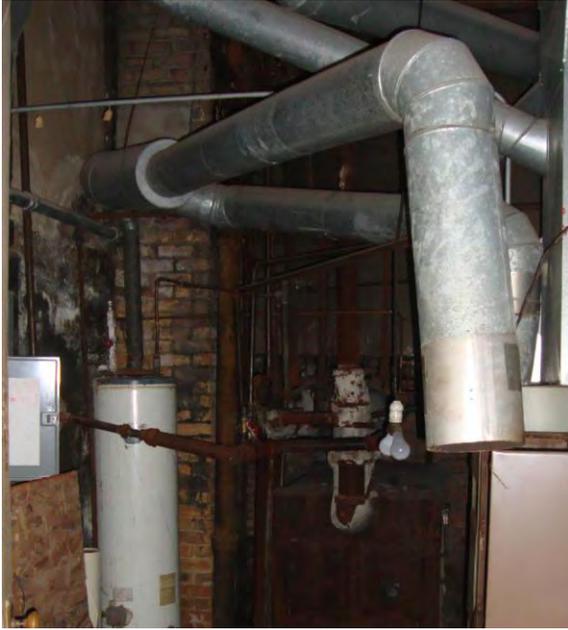
The mechanical room is crowded with the old boiler remaining in place and other outdated equipment intermixed with new equipment. Much of the older equipment is non-functional and should be removed to make room for new modern equipment.

Image 2.13. View into the boiler room, looking south.

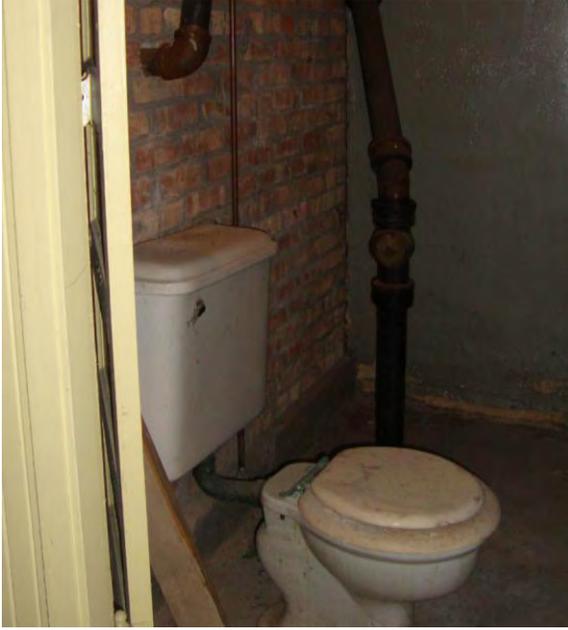
The plumbing system is vintage 1913. The system was reviewed by Bo Hachtel of Hachtel Plumbing, Inc. of Fort Atkinson. The water supply is galvanized steel pipe. Waste piping is cast iron. Modifications have been made over the years to accommodate kitchen changes and new toilets. Overall the waste piping appears to be functional but the walls of the pipe are thin and not reusable in a major rehabilitation effort. New water supply and waste piping throughout the building is warranted. The waste line from the building to the street should be checked for condition.

Image 2.14. View of the basement level toilet room. Note the exposed supply and waste piping.
