MASONIC TEMPLE - THE FORT ATKINSON CLUB CONDITION REPORT

Prepared by:
Charles Quagliana, AIA, NCARB
Preservation Architect
October 1, 2012

Building Envelope Condition Report

May 17, 2012

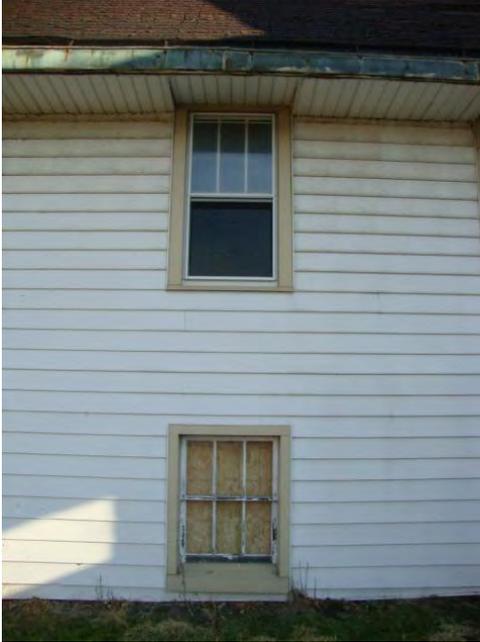
Image 1.11 Typical basement and first floor windows not covered with aluminum siding. South elevation.

All windows should be removed, stripped, repaired, prepared, primed, painted and reinstalled with new head flashing and surrounding trim.

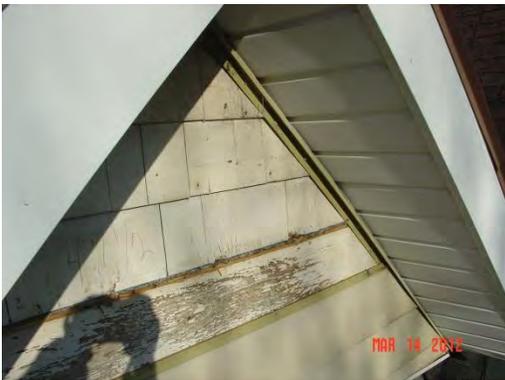
The eave system consists of pre-finished aluminum cladding over original painted (finished) wood members, including eave and rake boards (fascia), outriggers, and (roof) decking. The soffit cladding is non-perforated. The fascia is also clad. The condition of cladding is good and sound.

Image 1.13 Soffit/eave aluminum cladding as revealed at the east dormer gable roof.

Eventually, the soffit and fascia cladding may be removed to reveal the original wood members. The removal of cladding may coincide with the removal of the siding but performing this action will prove to be difficult if the siding remains in place due to the interlocking at the junctures of the wall and soffit aluminum cladding.

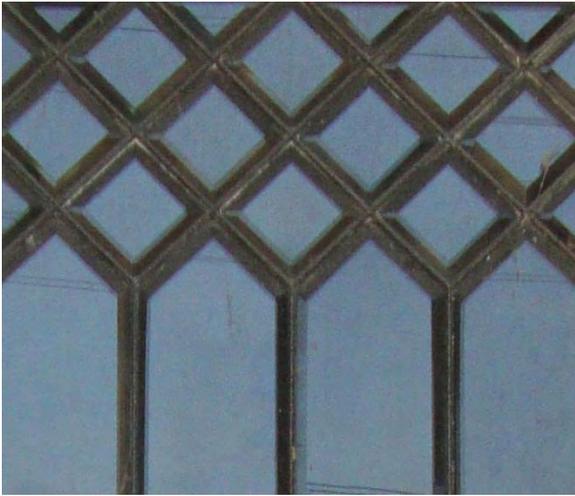
Image 2.1. Detail of entry door sidelight

The entrance door facing the street is a non-original flush steel door 32” in width. The surrounding sidelights and transom are original, dark stained wood in in good condition. The foyer floor is maple that has been improperly sanded and may not be able to be reused. This is in poor condition. Other entry doors at the east and north sides of the building are non-original 32” flush steel doors.

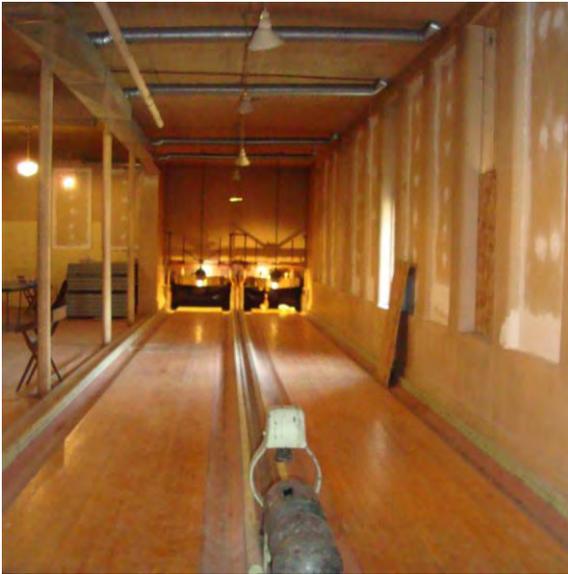
The bowling alley lanes are in very good condition with only minor work required to wood surfaces at the very eastern end of the lanes. The wood floor area between the east end of the lanes and the east wall of the basement is in poor condition and will require replacement.

Image 2.4. View of the bowling alleys looking west. Note the exposed ductwork and piping.

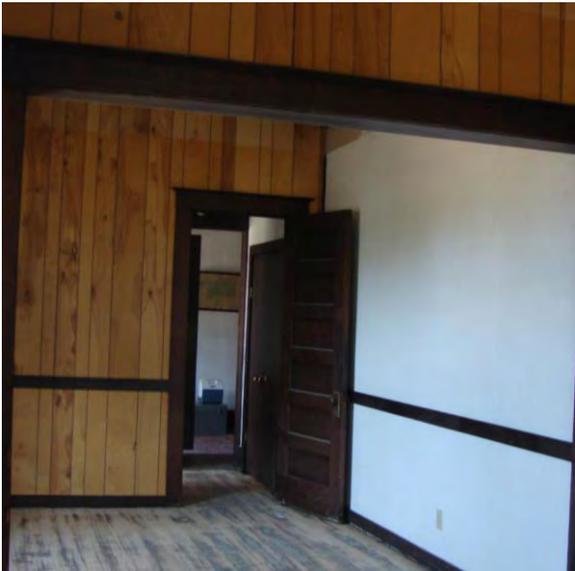
The two card rooms have been modified over the years including the addition of vertical wood paneling circa 1970, drop acoustic tile ceilings, the addition of a toilet at the east and the addition of a stair way to second floor. When the newer stair was put in between first and second floors many floor joists were cut and not properly supported. These can be supplemented and repaired. The stair will be removed.

Image 2.7. Card room looking west. The “new” stair is behind the white drywall wall on the right.

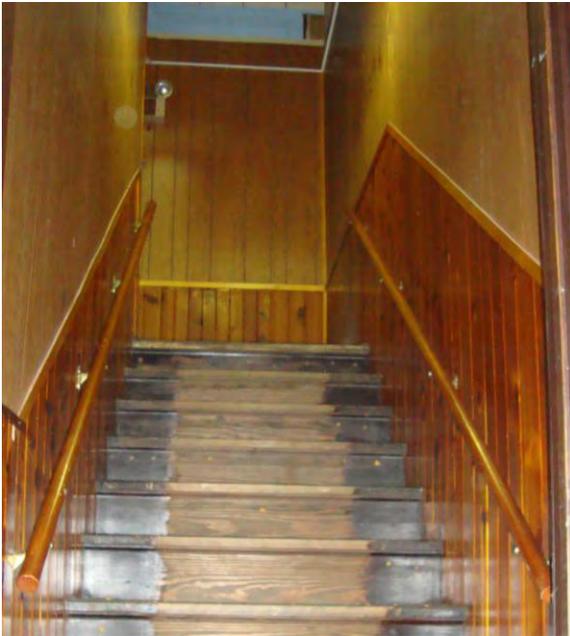
The original stair walls are surfaced with two types of wood panels circa 1970. The ceiling is covered with acoustic tile and the windows are filled in and covered by the paneling. The condition of the plaster wall behind the paneling is not known. The stair is approximately 45" wide and can meet current code if enclosed to make smoke tight.

Image 2.10. Stair at first floor looking up to the landing.
